# Annandale

## Pedestrian Walkway Feasibility Study

### Final Report

**Subject:** Project No. HCD53/Volkert No. 663802.60  
Annandale Pedestrian Walkway Feasibility Study

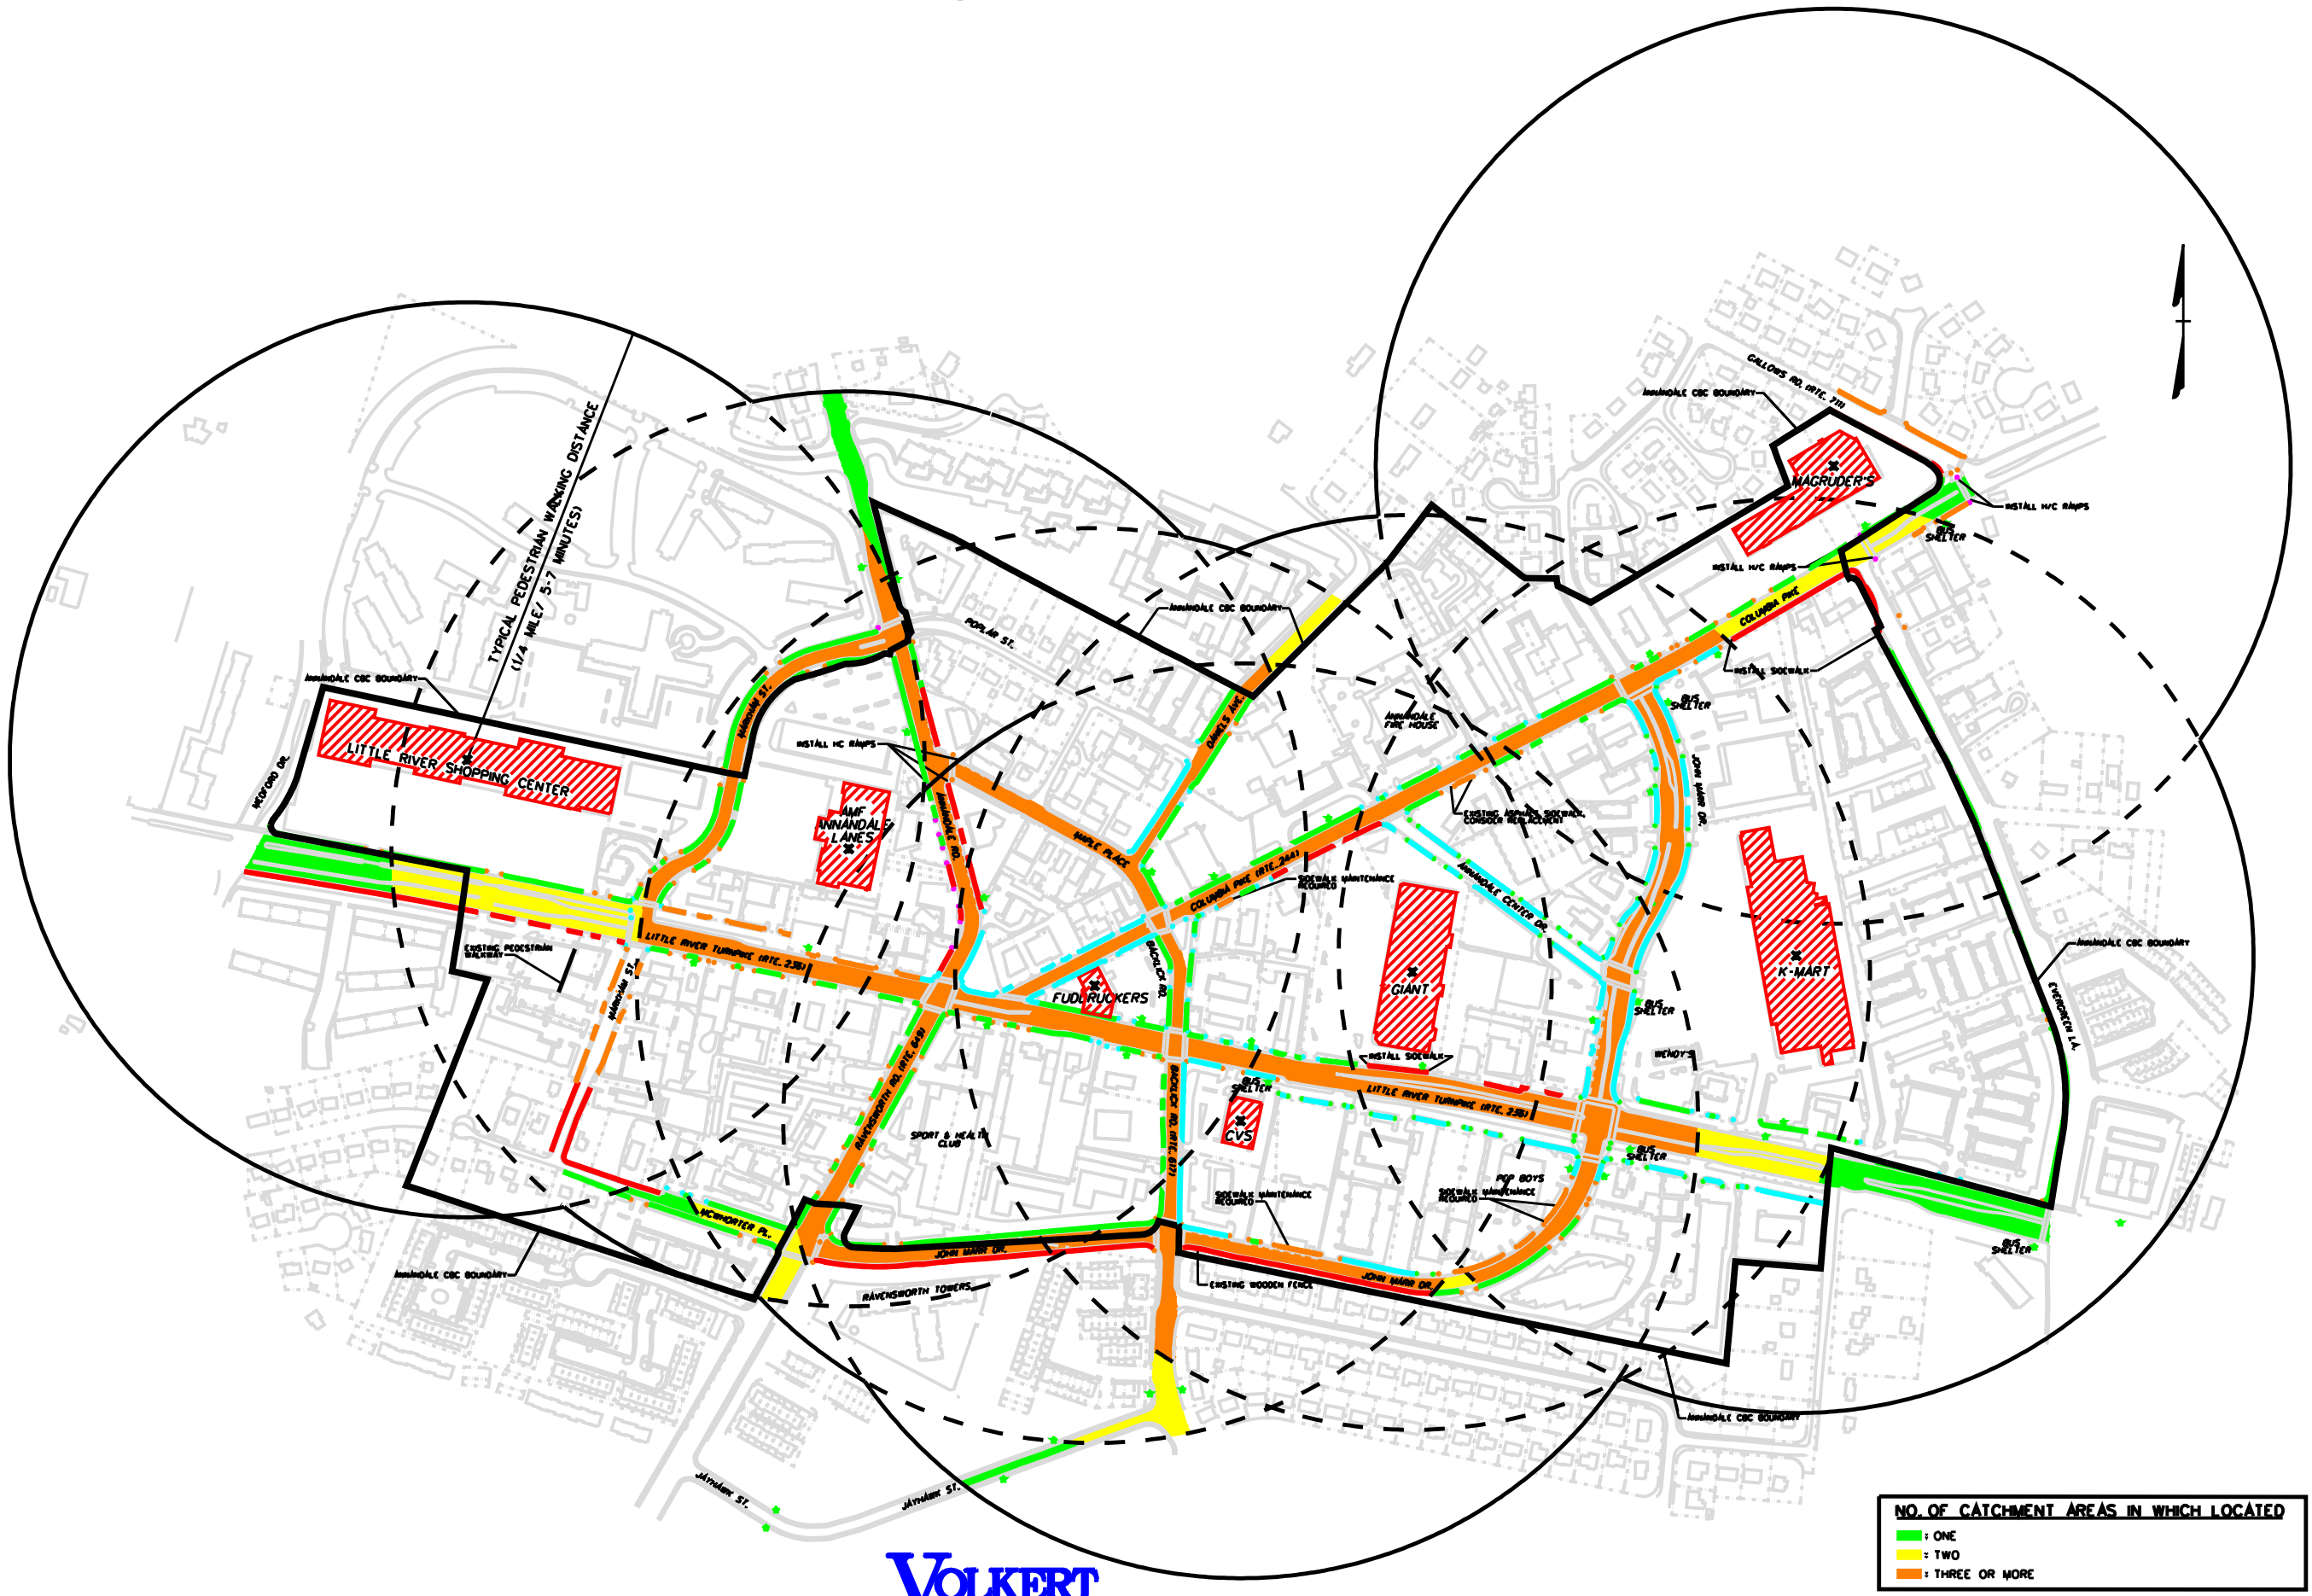
# FIGURE 12 - OVERLAPPING PEDESTRIAN CATCHMENT AREAS

NO. OF CATCHMENT AREAS IN WHICH LOCATED	
Green	: ONE
Yellow	: TWO
Orange	: THREE OR MORE

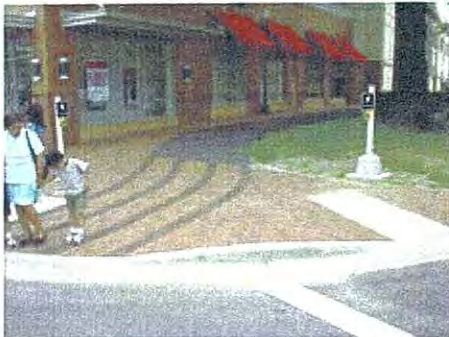
Pushbutton-integrated APS located on a stub pole beside the level landing of the curb ramp.

Devices are installed on all four corners, using stub poles for all in order to place the pushbuttons and APS at the top of the ramp for each direction, separated by at least 10 feet.

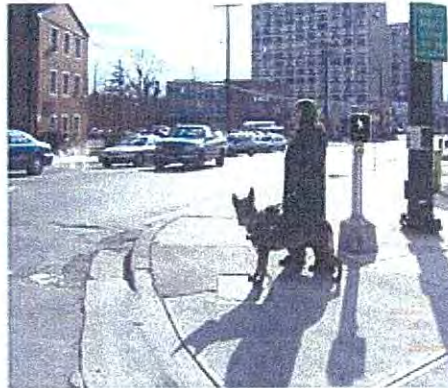
Pedestrian with dog guide at an APS located in line with crosswalk.

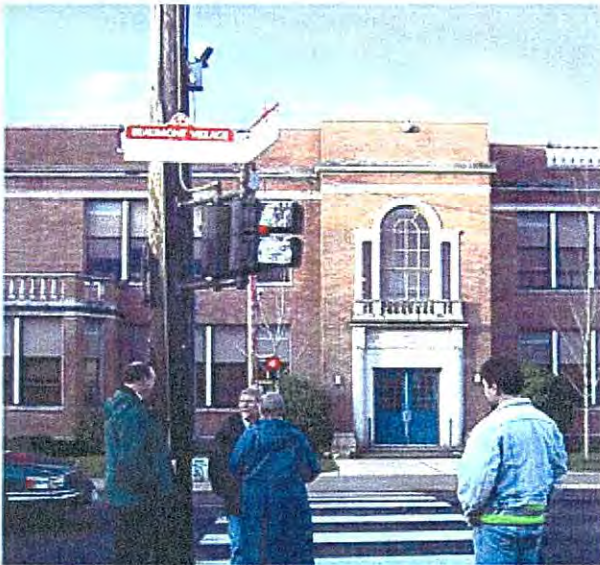
APS mounted over 12 feet high on the pole broadcast speech messages at this location in Portland. City engineers expressed concerns about intelligibility of the message.

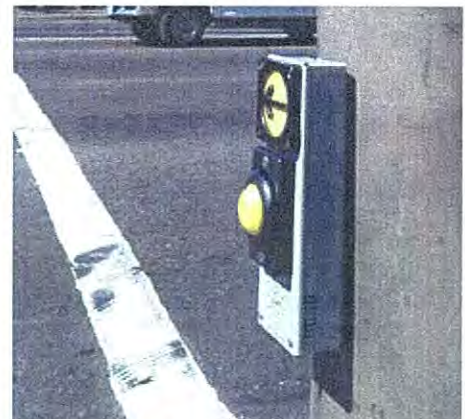
Vibrawalk pushbutton installed in Portland includes a locator tone. The arrow vibrates during the WALK interval and walk indication is provided from pushbutton or speaker mounted on the pedhead.

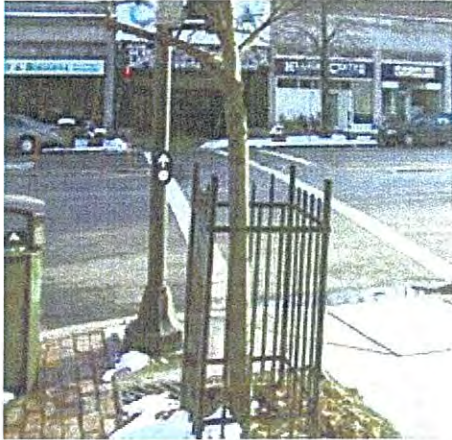
Panich APS at mid-block crossing, Newton, Mass. APS should have been mounted on side of pole closest to crosswalk, with arrow parallel to crosswalk rather than pointing up.

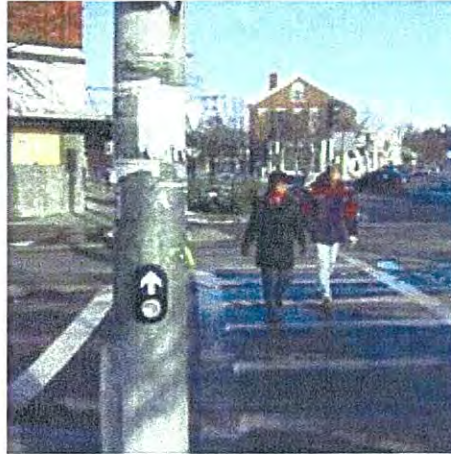
Panich APS for crossing the stem of a "T" intersection.

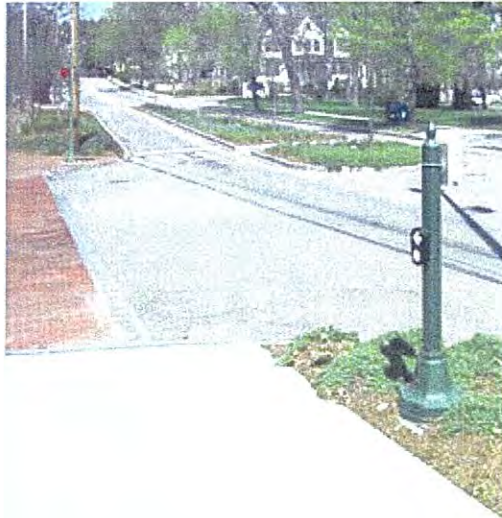
Panich APS on stub pole in Newton, Mass. arrow oriented parallel to crosswalk.

At another intersection at which APS were installed, a stub pole was installed in order to locate the pushbutton properly for one crosswalk.

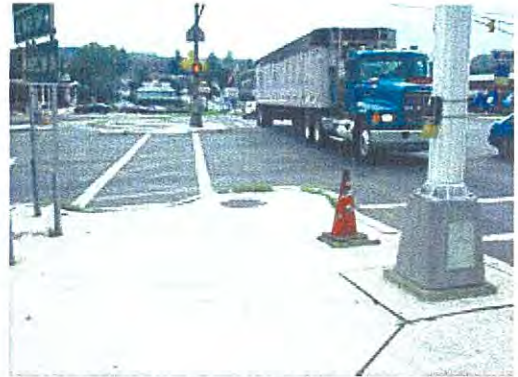
Installation of two pushbuttons on a single pole (only a single pushbutton is visible in the photo). While the pushbutton is in line with the crosswalk, the pedestrian must travel over 10 feet before reaching the street and the beginning of the crosswalk.

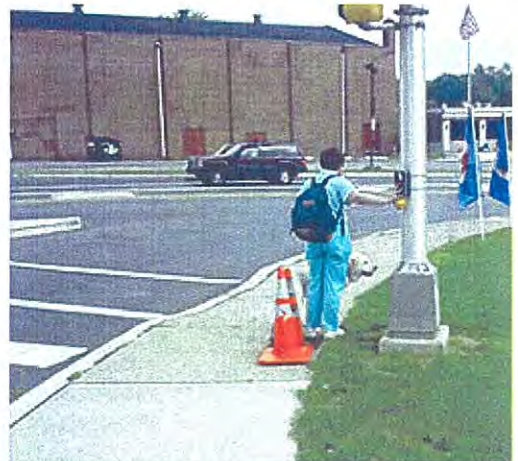
APS mounted on signal pole for crossing signalized right turn lane. A pedestrian who is blind is waiting with her hand on the pushbutton for the vibrotactile Walk indication. After the Walk indication begins, she must turn, and cross the sidewalk before beginning to cross the street.

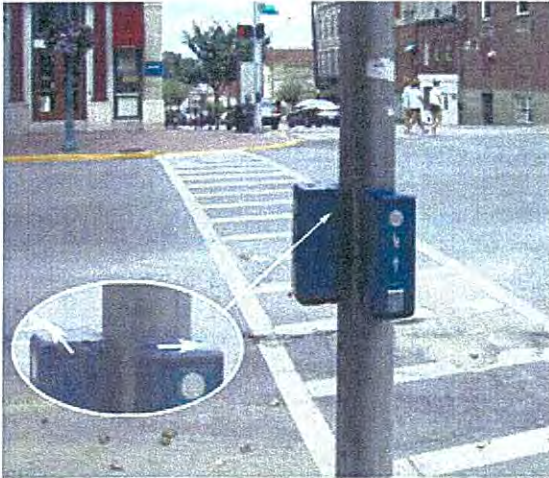
Mounting of two Prisma pushbutton units on a single pole. See arrows on insert detail for the orientation of the tactile arrow on the top of each unit. Both devices make the same sound during the Walk indication, which is acceptable in this installation since there is exclusive pedestrian phasing.

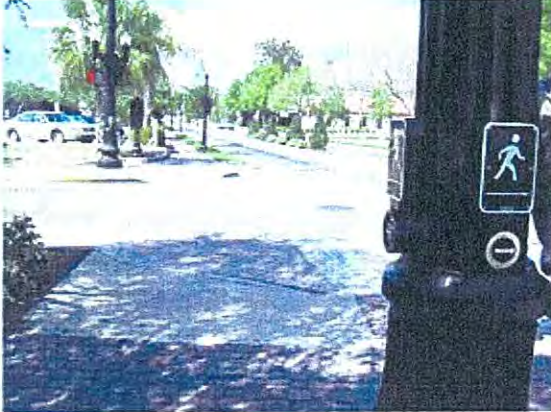
Two pushbuttons are located on fluted pole at this location with exclusive pedestrian phasing. Tactile arrow of each device points in the direction of travel on the crosswalk.

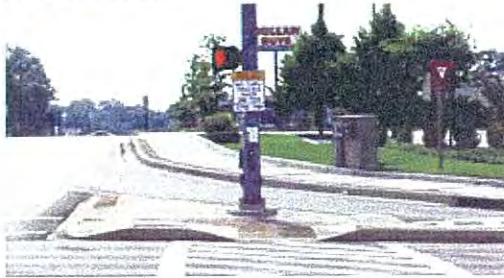
Two APS are mounted on the existing pole on this island.

Existing poles were used at this location with channelizing islands and uncontrolled right turn lanes in three of the four quadrants.

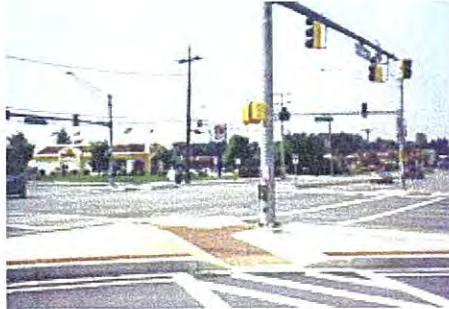
APS as seen from right-turn lane crossing.

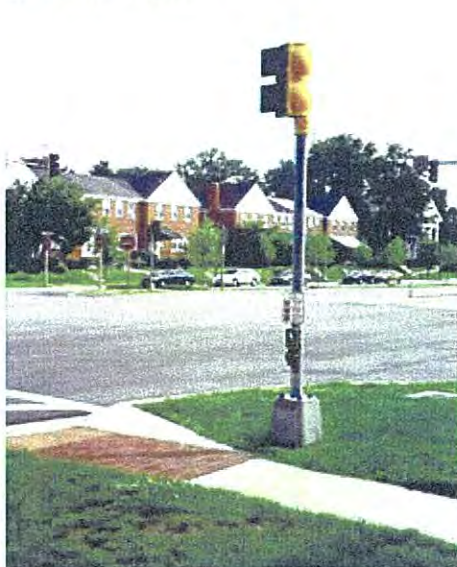
APS installed on pedestrian signal pole.

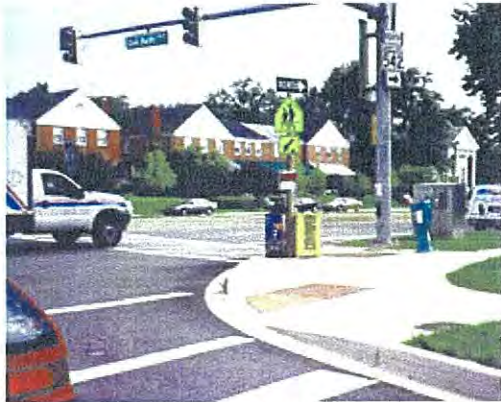
APS installed on signal pole beside crosswalk waiting location.

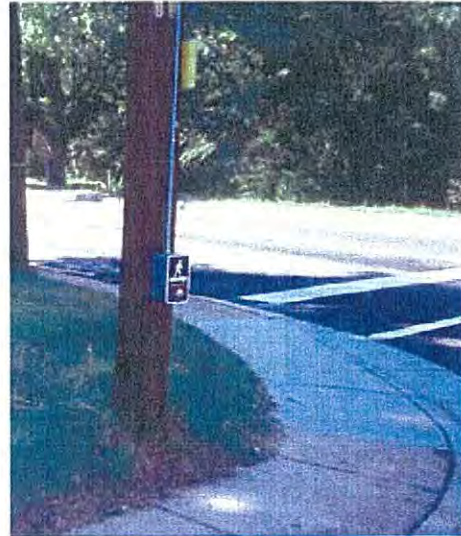
An early Polara installation in Charlotte.

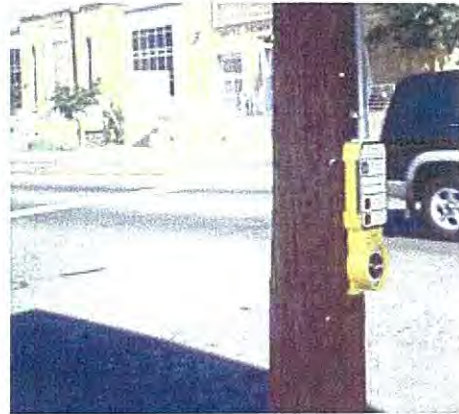
Recent Polara Navigator installation.

The newer version Polara Navigator has addressed all installation concerns.

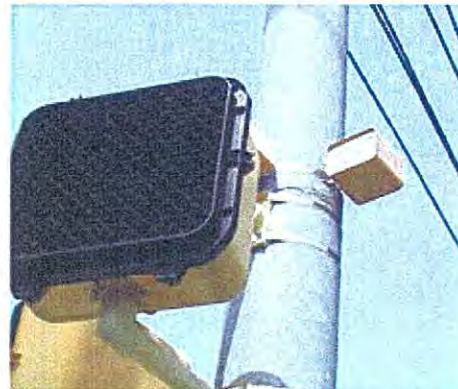
Pedhead-mounted speaker mounted on the pole as typically installed in Atlanta.

Many pedhead-mounted units have been installed for five to ten years or more without problems. Recently, two units failed two consecutive times until engineers found that water was getting into the devices, probably through the speaker holes. They recommend double checking the seals and mounting the speakers under the pedheads to protect them from the impact of heavy rain.
